# *The Herr House*

## *A Gem of Domestic Architecture*

By Henry J. Kauffman

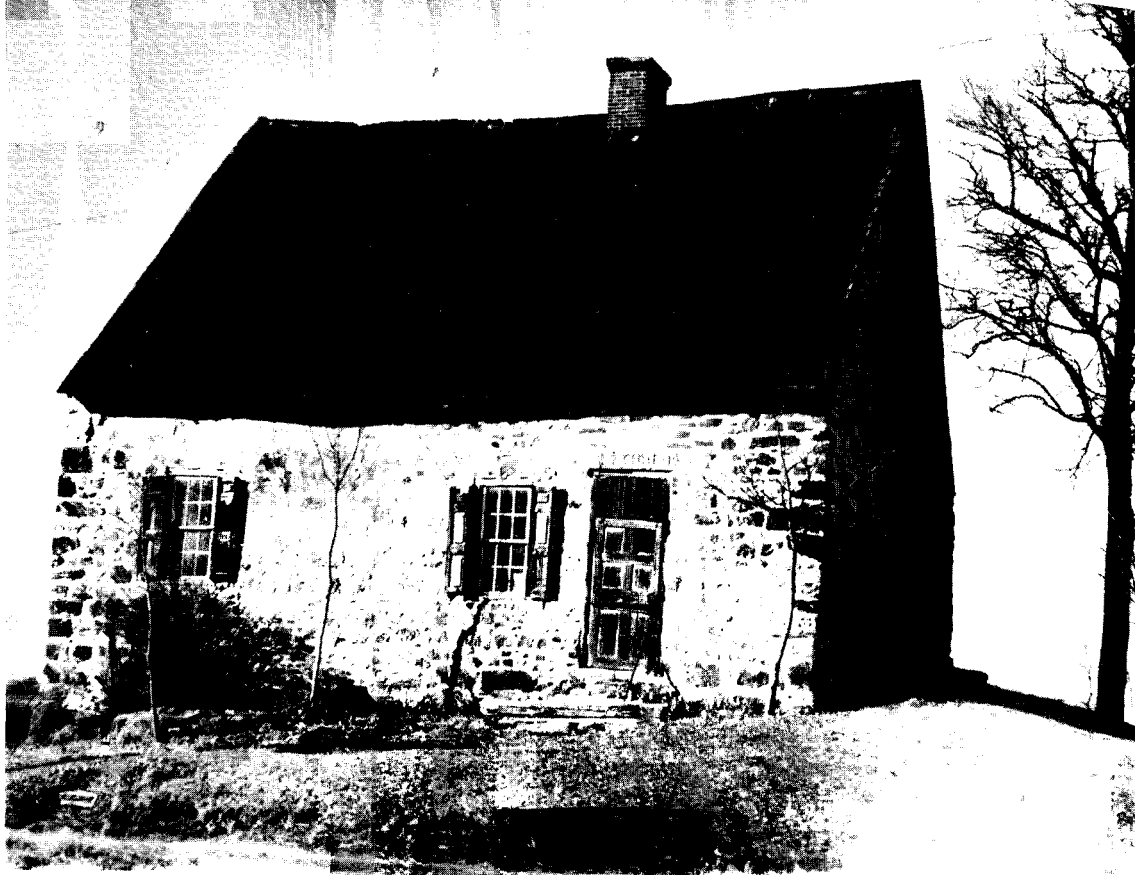
*The Herr House before recent renovation.*

Although the Herr house seemed to be decaying in recent years, it remained a reasonably sound structure because it had a good roof. An examination of the roof testifies to the fact that it is a Germanic structure. It is very long and has a very sharp pitch. The sharpness of the pitch is a northern European feature, so constructed to shed the heavy snows of the region. By looking at the gable end of the house it is evident the roof encloses two floors, an arrangement often called a "double attic." The Saron at the Ephrata Cloister has a triple attic as do many buildings surviving in Germany today. It is not known what kind of material was used to cover the roof; however, it might well have been thatch. Many buildings in Europe have thatched roofs today, a good one reputed to last as long as twenty-five years. The absence of a functioning potter at such an early date discounts the possibility of a tile roof. In the recent restoration hand-shaped shingles were used with a lap sidewise and at the end. Strangely, there were no pent roofs on the Herr house, nor was there a "kick" on the eaves. A "kick" is a sharp rise at the bottom edge of the roof, presumably to throw water away from the wall of the house, a matter of much importance in a log house, but of lesser import in one of stone.

The random shape of the stones in the exterior wall—partially concealed with an overlay of mortar—confirms the fact that they were gathered from the fields. Before restoration the exact shape and size of every stone could be de-

terminated easily. It appeared to have been pointed carefully; however, much of the mortar might have been eroded by rains over many years. Some early stone houses and churches were covered completely with mortar to make them watertight.

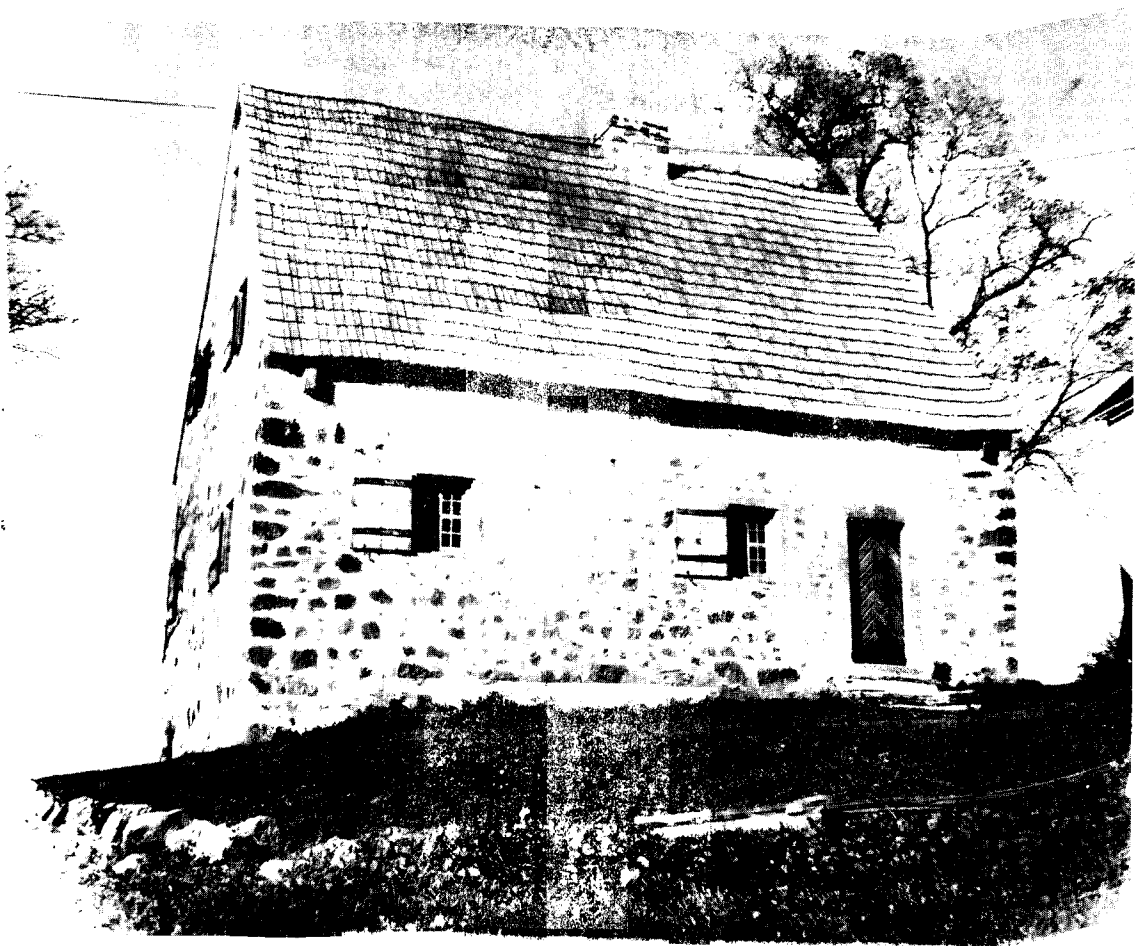
*The restored Herr House.*

In an earlier restoration the window openings on the first floor were enlarged and the stone stiles removed because they no longer were needed to support the new double-hung windows. In the recent restoration the stone stiles were restored and hinges were installed for the new shutters. Although it was a common procedure in early houses to use sills and lintels of stone or brick, a window framed completely with stone parts was a very unusual practice. Only a few houses in the "Dutch" country have this feature. New shutters of vertical boards were installed which is entirely consistent with the balance of architectural details. Casement sash have replaced the double-hung windows.
